# The Home Record

*The plan for the house, and the details behind it*

18 Quiet Hollow Court, The Woodlands, TX 77382

September 18, 2026

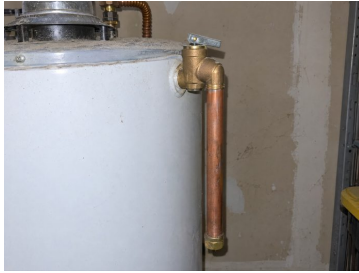
Water heater 1 (Garage, gas tank)

**The relief valve line is capped.**

*If it is left* A capped line disables the safety valve. A tank that overheats has no way to relieve pressure.

A licensed plumber, arranged by Almanac. The contractor quotes it.

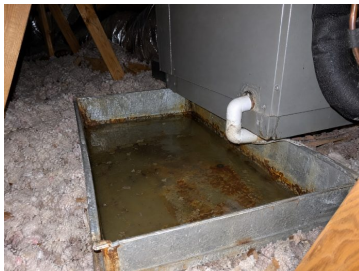
HVAC system 1 (Attic, Whole house)

**There is standing water in the air conditioner's secondary pan.**

*If it is left* This usually means the primary drain is blocked; an overflow here can cause water damage.

A licensed HVAC contractor, arranged by Almanac. The contractor quotes it.

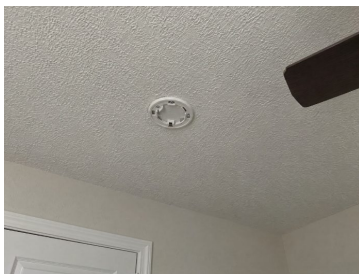
Smoke alarm in a bedroom · Primary bedroom

**The primary bedroom has no smoke alarm. The nearest one is in the hall outside it.**

*If it is left* With the door closed, smoke from a fire in the room reaches the hall alarm later. An alarm inside each bedroom is the standard.

A licensed electrician, arranged by Almanac. The contractor quotes it.

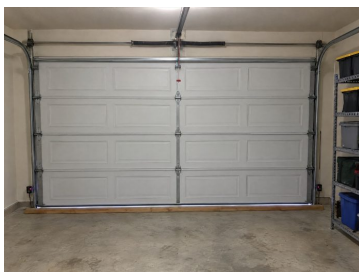
Garage door auto-reverse · Garage

**The garage door does not reverse when it closes onto a board on the floor.**

*If it is left* A door that does not reverse can trap a child beneath it. CPSC advises disengaging the opener until it is adjusted or repaired.

Almanac quotes it after the visit.

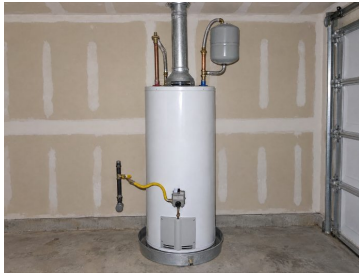
Water heater 1 (Garage, gas tank)

**The water heater is 11 years old, near the end of its expected life.**

*If it is left* Tanks this age can leak or burst. Budgeting now avoids an emergency replacement.

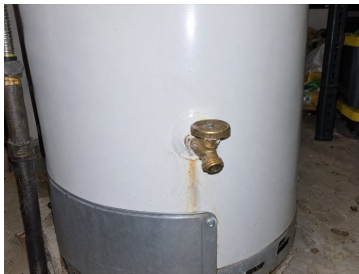
Water heater 1 (Garage, gas tank)

**The water heater has not been flushed in over a year.**

*If it is left* Sediment builds on the tank bottom and can shorten its life.

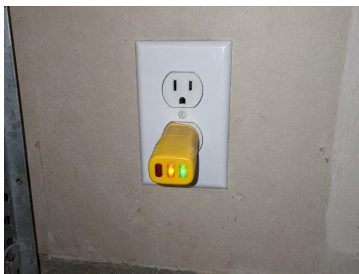
Garage receptacles · Garage

**The two garage wall receptacles are not GFCI protected.**

*If it is left* Garage floors can be wet, and tools plug in here. GFCI protection is the standard for garage receptacles.

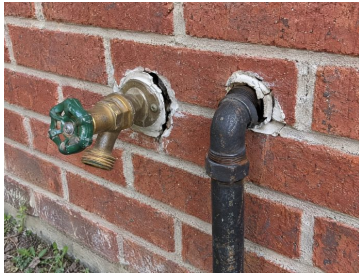
Caulk at penetrations · West wall

**The caulk around the hose bib, the dryer vent and the gas line on the west wall has split.**

*If it is left* Open joints let in water, air and insects; Almanac recommends resealing the whole house as one job.

Almanac: Exterior caulking and penetrations sealed, per 30 linear ft.

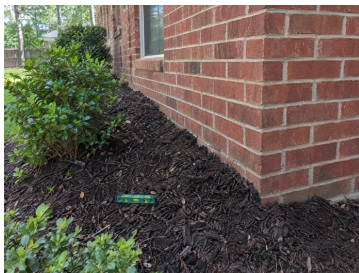
Grading at the foundation · Back of the house, east corner

**At the back east corner the ground slopes toward the house, and mulch sits against the brick above the slab edge.**

*If it is left* Water held at the slab wets the clay under that corner. Regrading and lowering the mulch let it drain away.

Almanac quotes it after the visit.

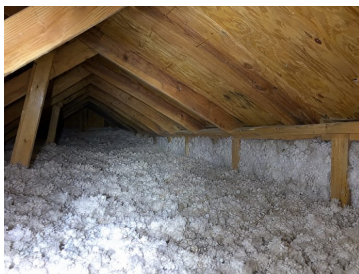
Soffit vents · Attic, north eave

**Blown-in insulation has been pushed into the eaves and blocks the soffit vents along the north side.**

*If it is left* Ridge vents need intake at the eaves to work as designed. With the soffits blocked, the attic vents poorly and cooling use can rise.

Almanac quotes it after the visit.

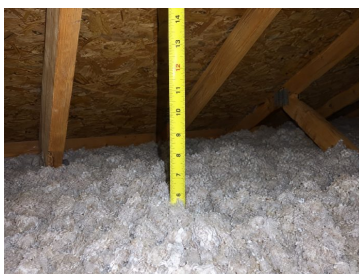
Attic insulation depth · Attic

**The blown-in insulation measures about 6 inches, roughly R-19, against the R-38 to R-49 recommended for this climate.**

*If it is left* Thin insulation raises heating and cooling bills every month. EPA estimates that sealing and insulating save an average of 15 percent on them.

Almanac: Attic insulation topped up, per 500 sq ft.

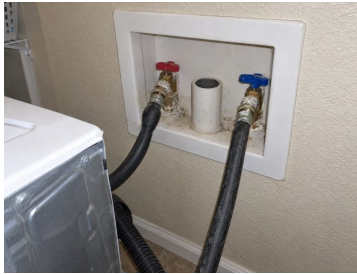
Laundry 1 (Laundry room)

**The washing machine hoses are rubber or over eight years old.**

*If it is left* A burst hose releases water at full pressure until someone shuts it off.

Almanac: Washer and dryer connected to existing hookups.

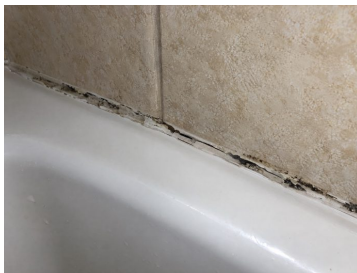
Tub and shower caulk · Hall bathroom

**The caulk between the tub and the tile wall in the hall bathroom has cracked and gone black.**

*If it is left* Shower water can leak through the gap into the wall and floor, where it cannot be seen.

Almanac: Full bathroom caulk and re-seal, tub or shower surround.

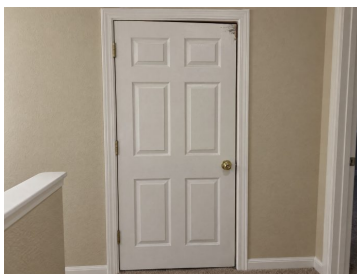
Interior doors · Bedrooms 2 and 3, hall bathroom, pantry

**Four interior doors bind or do not latch: bedrooms 2 and 3, the hall bathroom and the pantry.**

*If it is left* Almanac records several binding doors in one house as a pattern. Each is photographed before it is eased, and the count is compared next year.

Almanac: Sticking interior door adjusted, planed and re-hung.

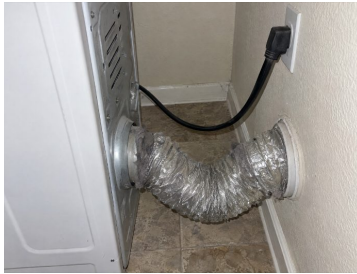
Laundry 1 (Laundry room)

**THIS YEAR****The dryer connects with a foil transition duct.**

*If it is left* Foil and plastic ducts trap more lint and crush easily; uncleaned lint is the leading factor in home dryer fires.

Almanac: Dryer vent run cleaned.

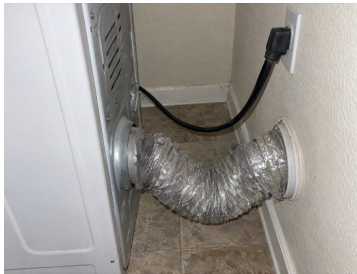
Laundry 1 (Laundry room)

**THIS YEAR****The dryer duct is crushed or lint has built up at the connection.**

*If it is left* Restricted airflow lengthens drying; overheating can start a fire.

Done in the same job: Dryer vent run cleaned.

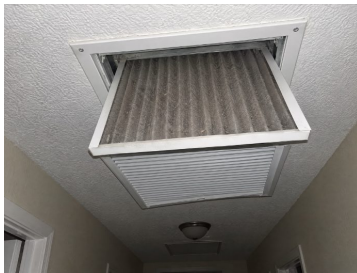
HVAC system 1 (Attic, Whole house)

**YOU CAN DO IT****The 20x25x1 air filter is due for a change.**

*If it is left* A dirty filter makes the system work harder and cool less.

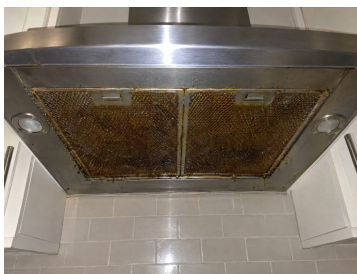
Kitchen 1 (Main kitchen)

**YOU CAN DO IT****The range hood filter is greasy or missing.**

*If it is left* Built-up grease reduces airflow and raises the fire risk.
